REPORT#: 17KY034

REPORT DATE: 6-29-2018

Dump Truck Driver Loses Control and Flips Truck Resulting in Fire

Fatality Assessment & Control Evaluation

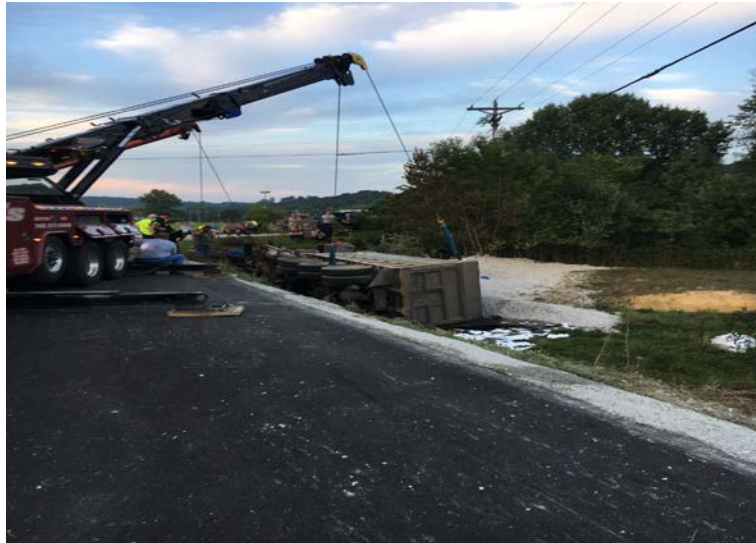
Photo 5: Crashed dump truck. (Photo courtesy of witness)

When the flames became too dangerous, the neighbors retreated to safety. Within four minutes, the cab became engulfed in flames. The local fire department arrived at the scene within five minutes of receiving the call and put out the flames. The truck driver was pronounced dead at the scene by the coroner.
