REPORT#: 17KY034

REPORT DATE: 6-29-2018

Dump Truck Driver Loses Control and Flips Truck Resulting in Fire

Fatality Assessment & Control Evaluation

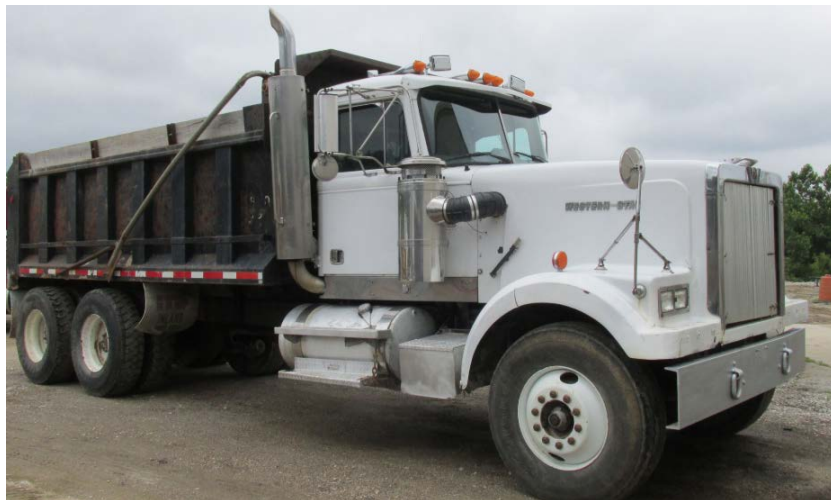
The truck left the roadway on the passenger side and flipped onto its right side into the culvert eight feet below the highway. As the truck flipped, the fuel tank struck a piece of rebar that was protruding from the concrete retaining wall leading to a water drainage tunnel under the highway. The fuel tank ruptured, causing a small fire in the engine that rapidly began to spread as fuel leaked from the tank.

Photo 4: 1987 Western Star 4900 series dump truck (Stock photo)

Discussion: Large truck manufacturers should consider an engineering redesign and new placement of fuel tanks within all trucks. With the high number of truck crashes that result in fire, this redesign could save lives as well as equipment. According to the Bunn et al. (2012), large truck vehicle fire rates in Kentucky were significantly increased when compared to light trucks and passenger cars.⁶ The study recommended the fuel tanks would be better protected within the truck body and not exposed.
